**Re: Administrative Order on Consent for Removal Action, Docket No. VW-05-C-810
Removal Action Work Plan for Village Harbor Southwest Corner**

**Removal Action Work Plan
Village Harbor Southwest Corner**

Little Traverse Bay CKD Release Site
Emmet County, Michigan

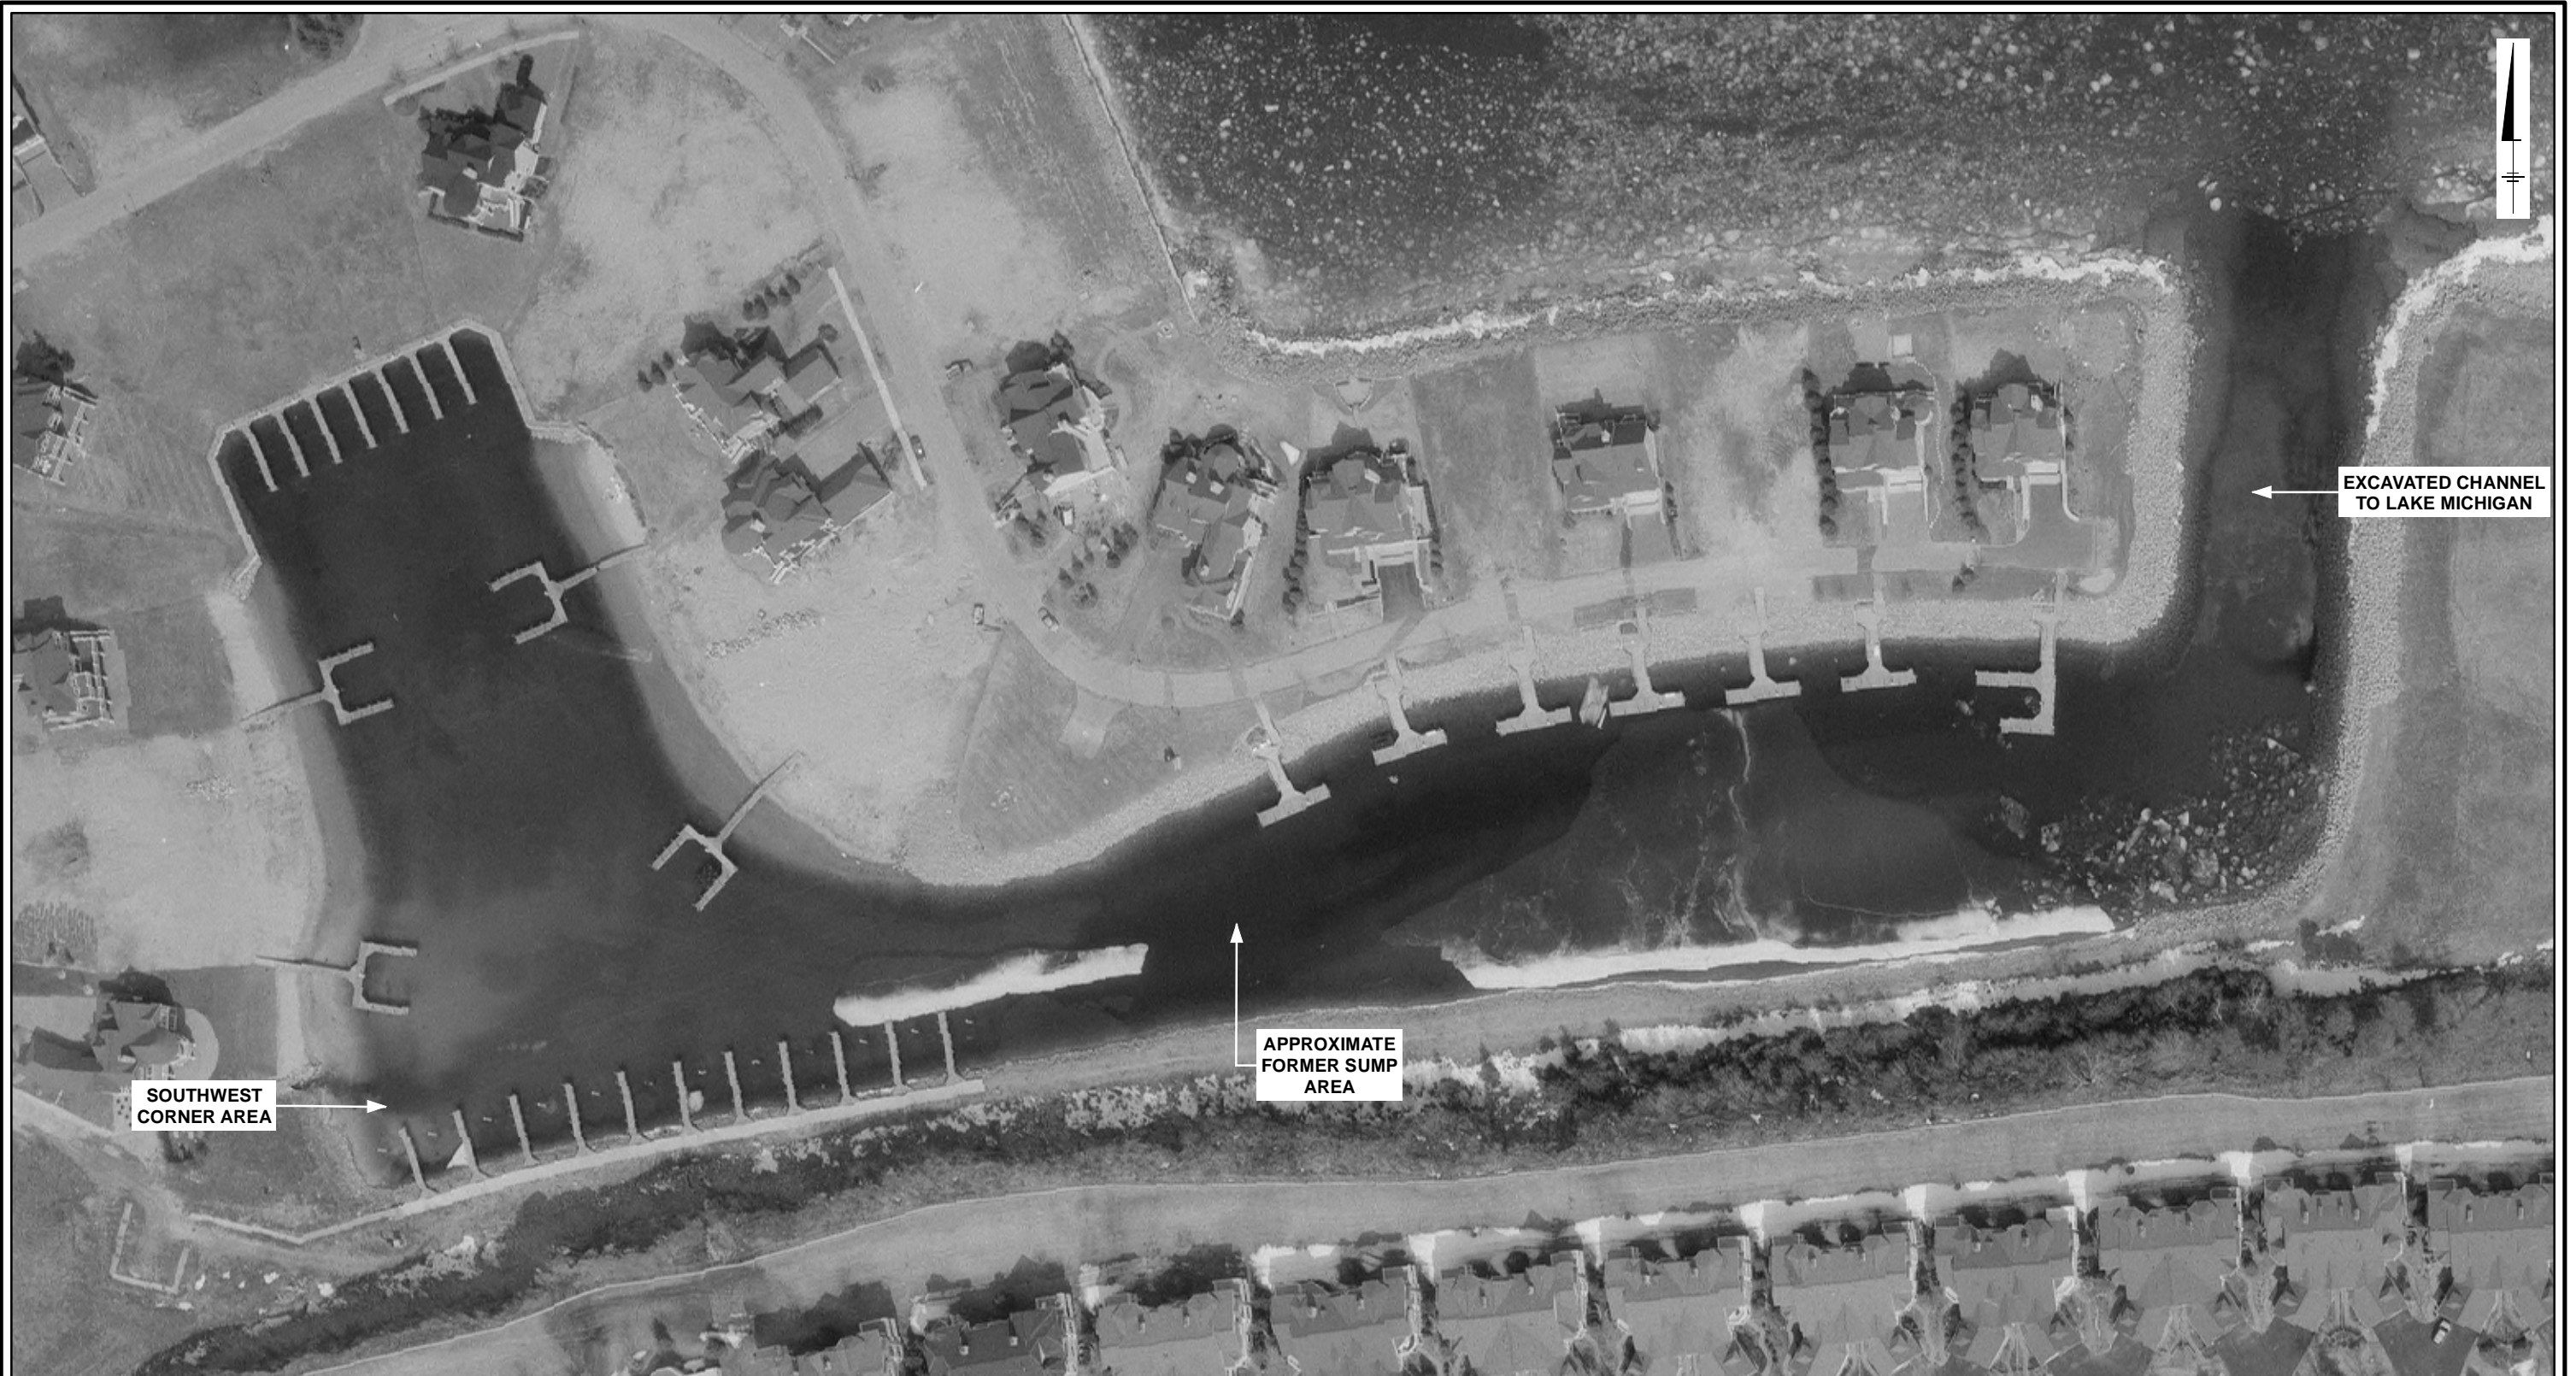
**FIGURE
1-2**

1. AERIAL PHOTO COLLECTED IN APRIL 2005
PROVIDED IN GEOREFERENCED FORM BY
BARR ENGINEERING, INC.

“Village Harbor” as used in this Removal Action Work Plan refers to the water body located immediately west of Resort Township’s East Park and immediately east of the Bay Harbor commercial district. A site location map for Village Harbor is shown on Figure 1-1, and a site plan for Village Harbor is shown on Figure 1-2.

Village Harbor is approximately 1,200 feet long and 150-200 feet wide, as shown on Figure 1-2. It is elongated in the east-west direction, with a western arm that becomes

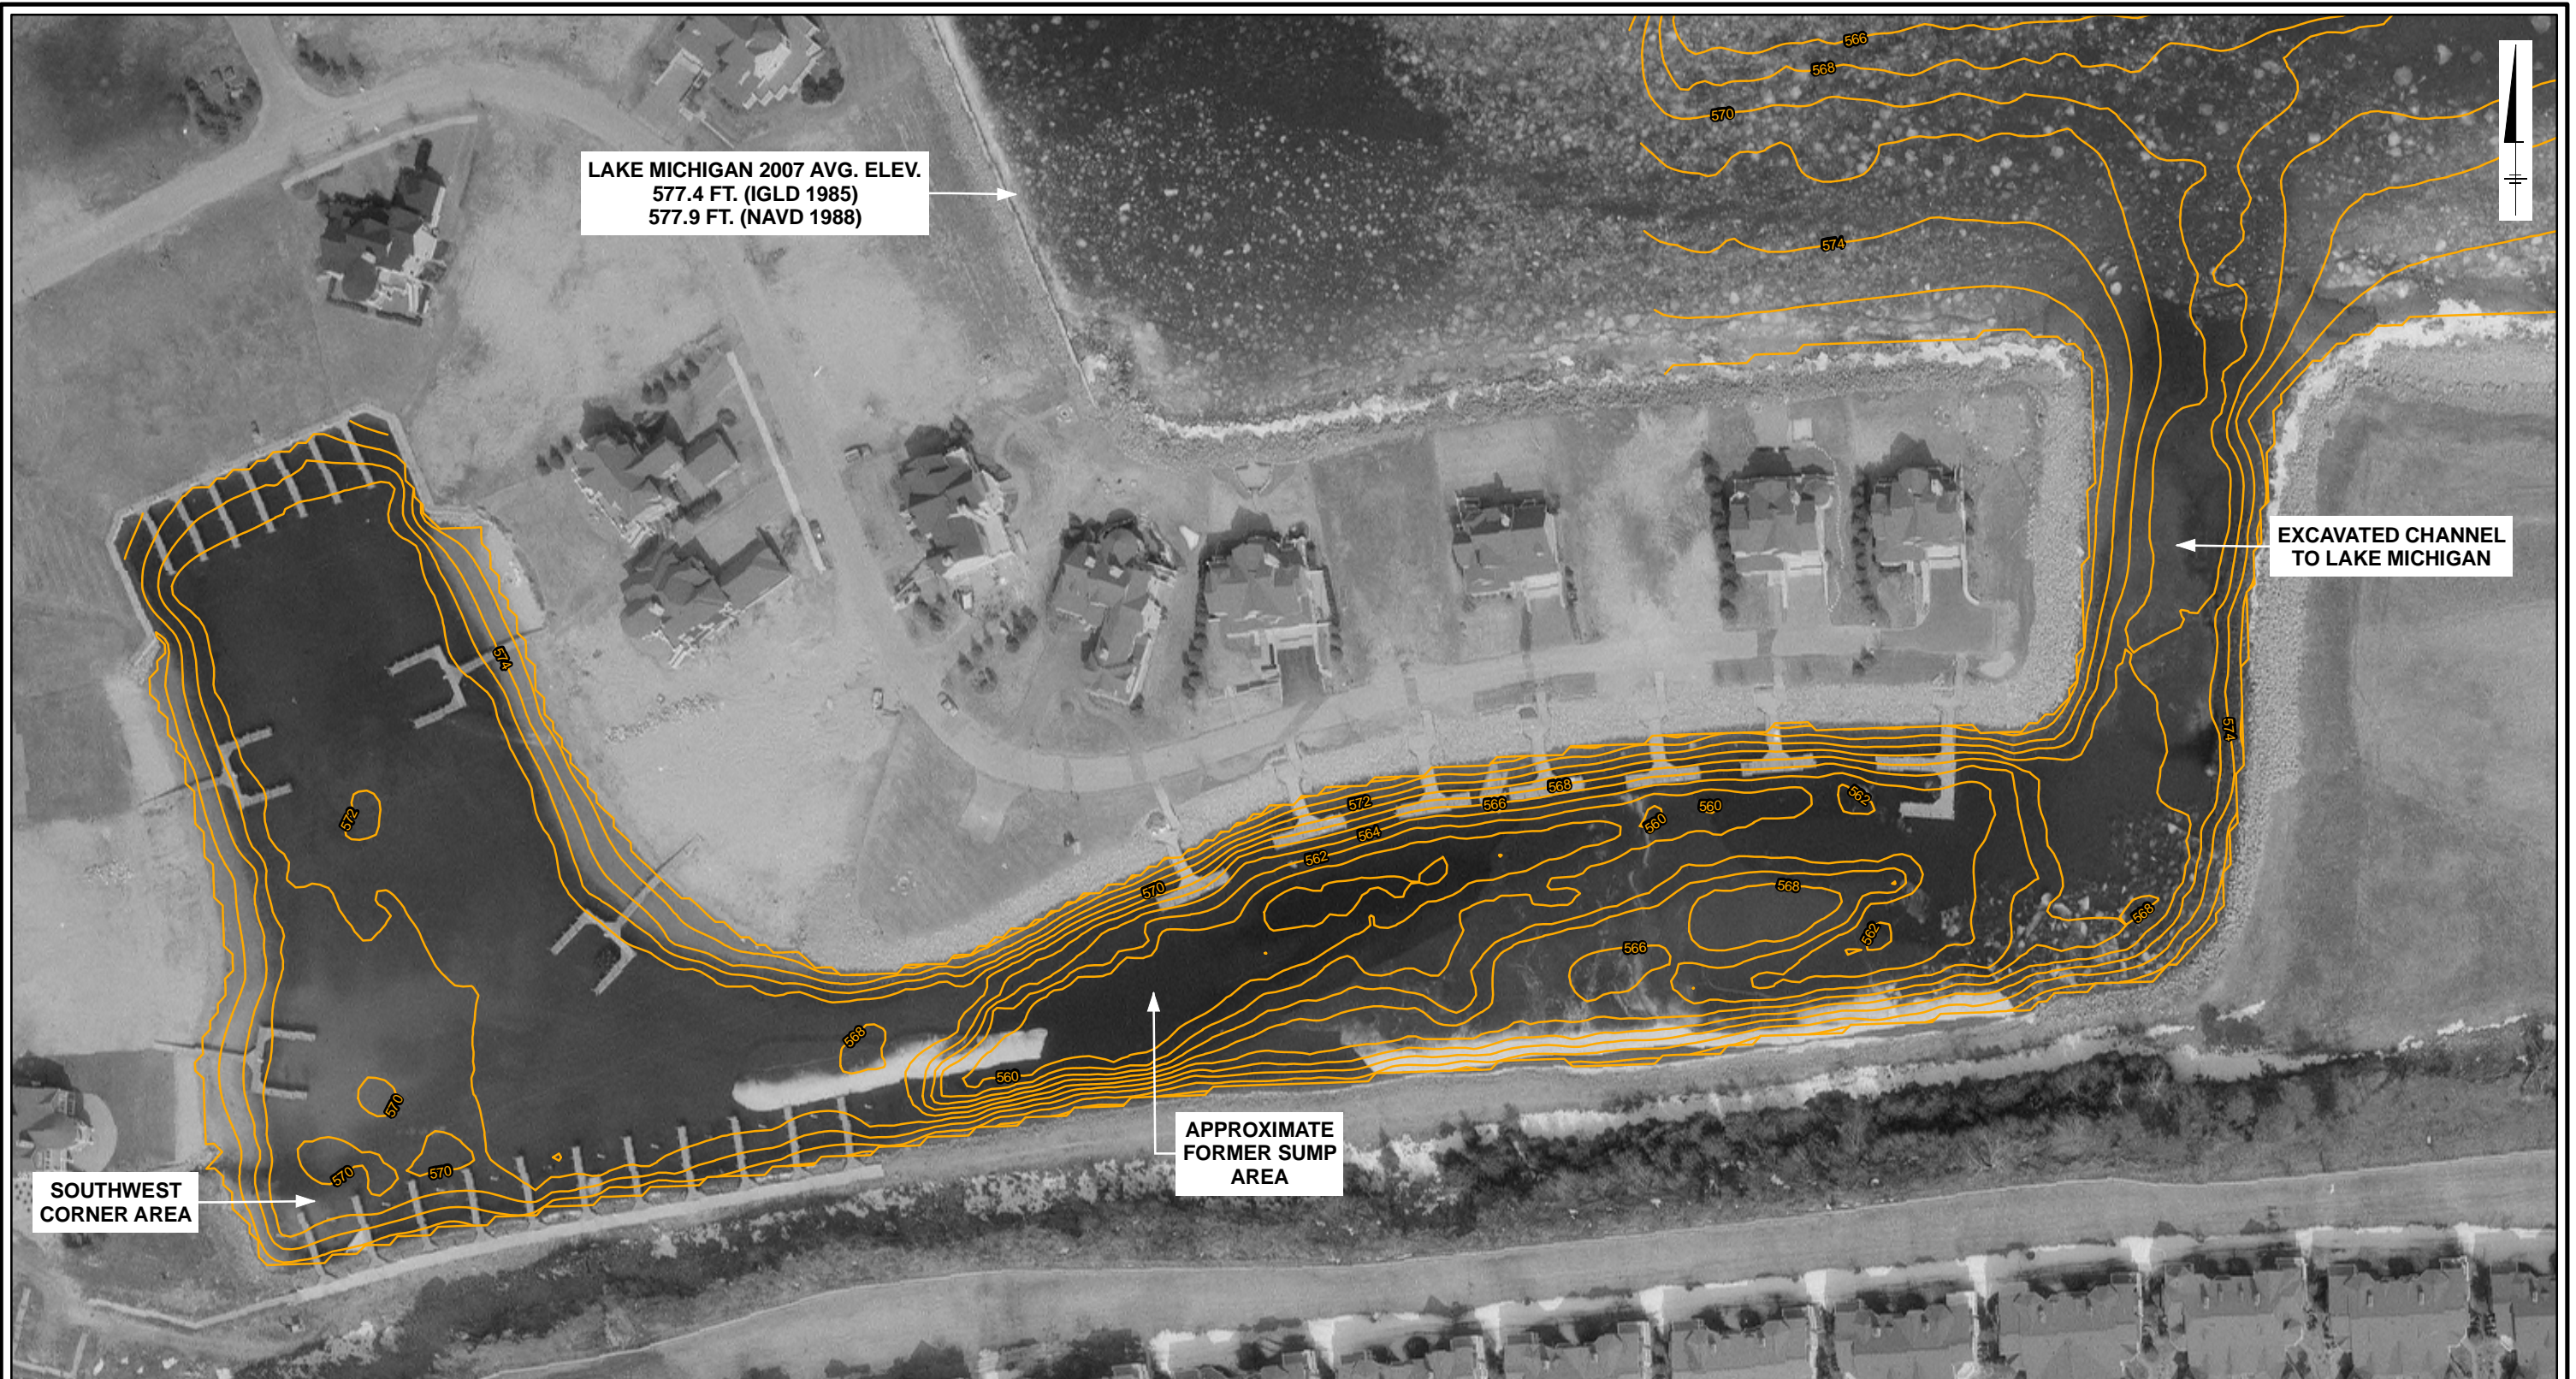
FIGURE
1-3

— BATHYMETRY ELEVATION CONTOUR - 2 ft

A detailed bathymetry survey of Village Harbor, was performed by eTrac Engineering, LLC (eTrac) on September 9 and 10, 2006. The resulting bathymetry is shown on Figure 1-3, and shows that the historic “sump area” visible in historical aerial photographs and topographic maps remains a topographic low. Water in the sump area is essentially isolated from Little Traverse Bay by a sill 8 to 10 feet high. This sill appears to prevent frequent mixing between bottom waters in the sump area and the overlying water of Village Harbor, allowing stagnation of bottom waters in the sump area.

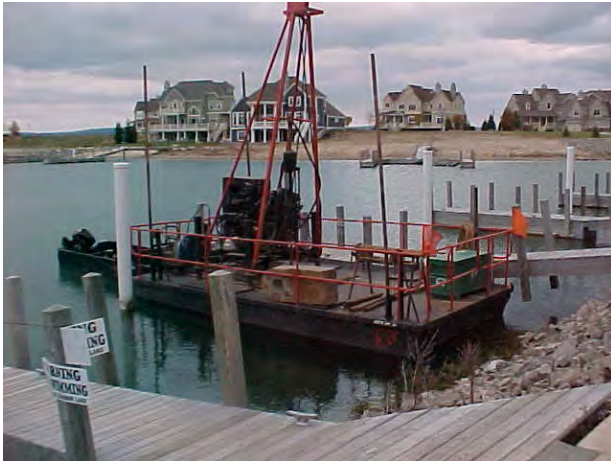
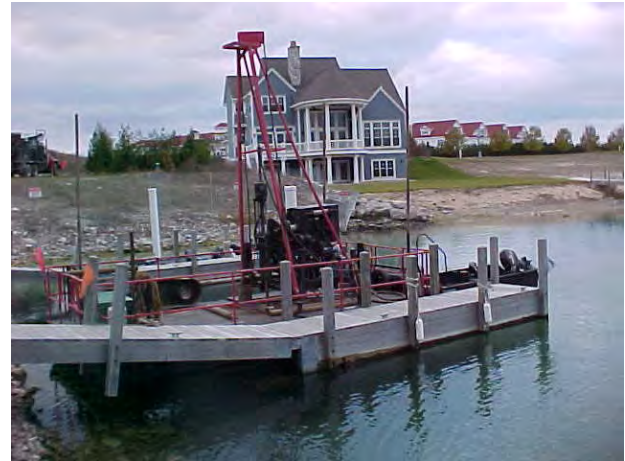
Barge and rig installed into dock slip
(view from southwest)

Barge and rig installed into dock slip
(view from southeast)

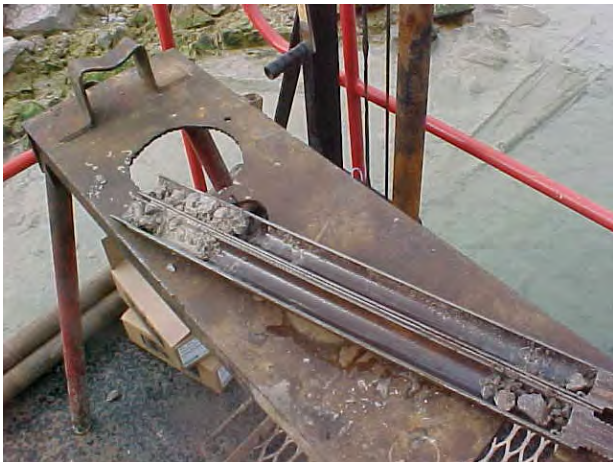
Open split-spoon sampler with sample

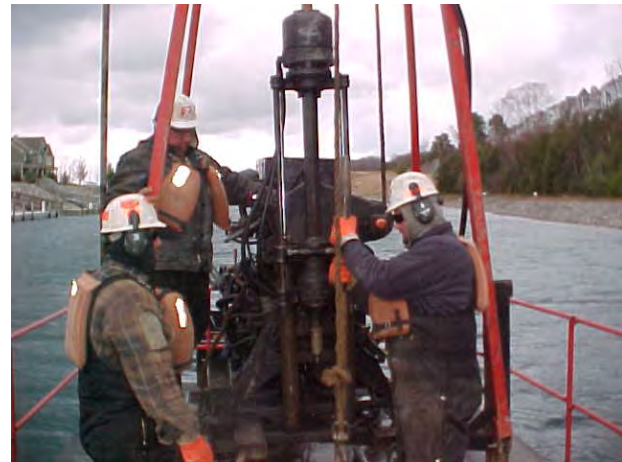
Attaching smaller diameter rod to advance
split-spoon sampler

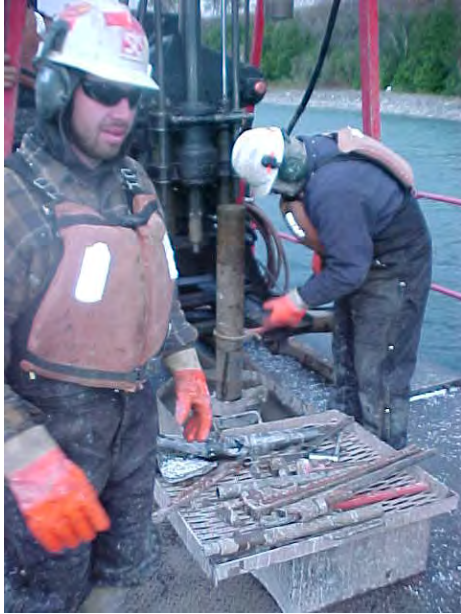
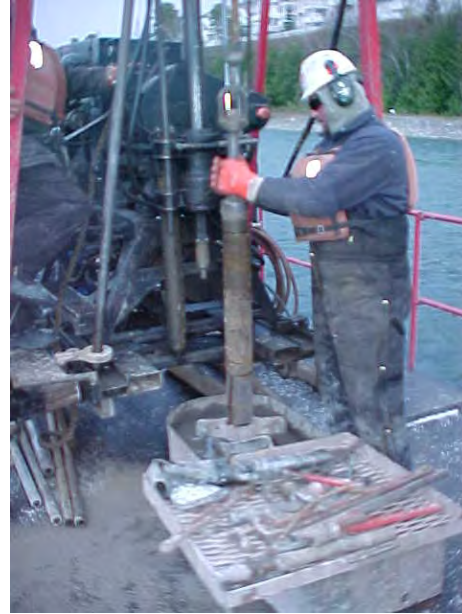
Attaching section of outer casing prior to advancement

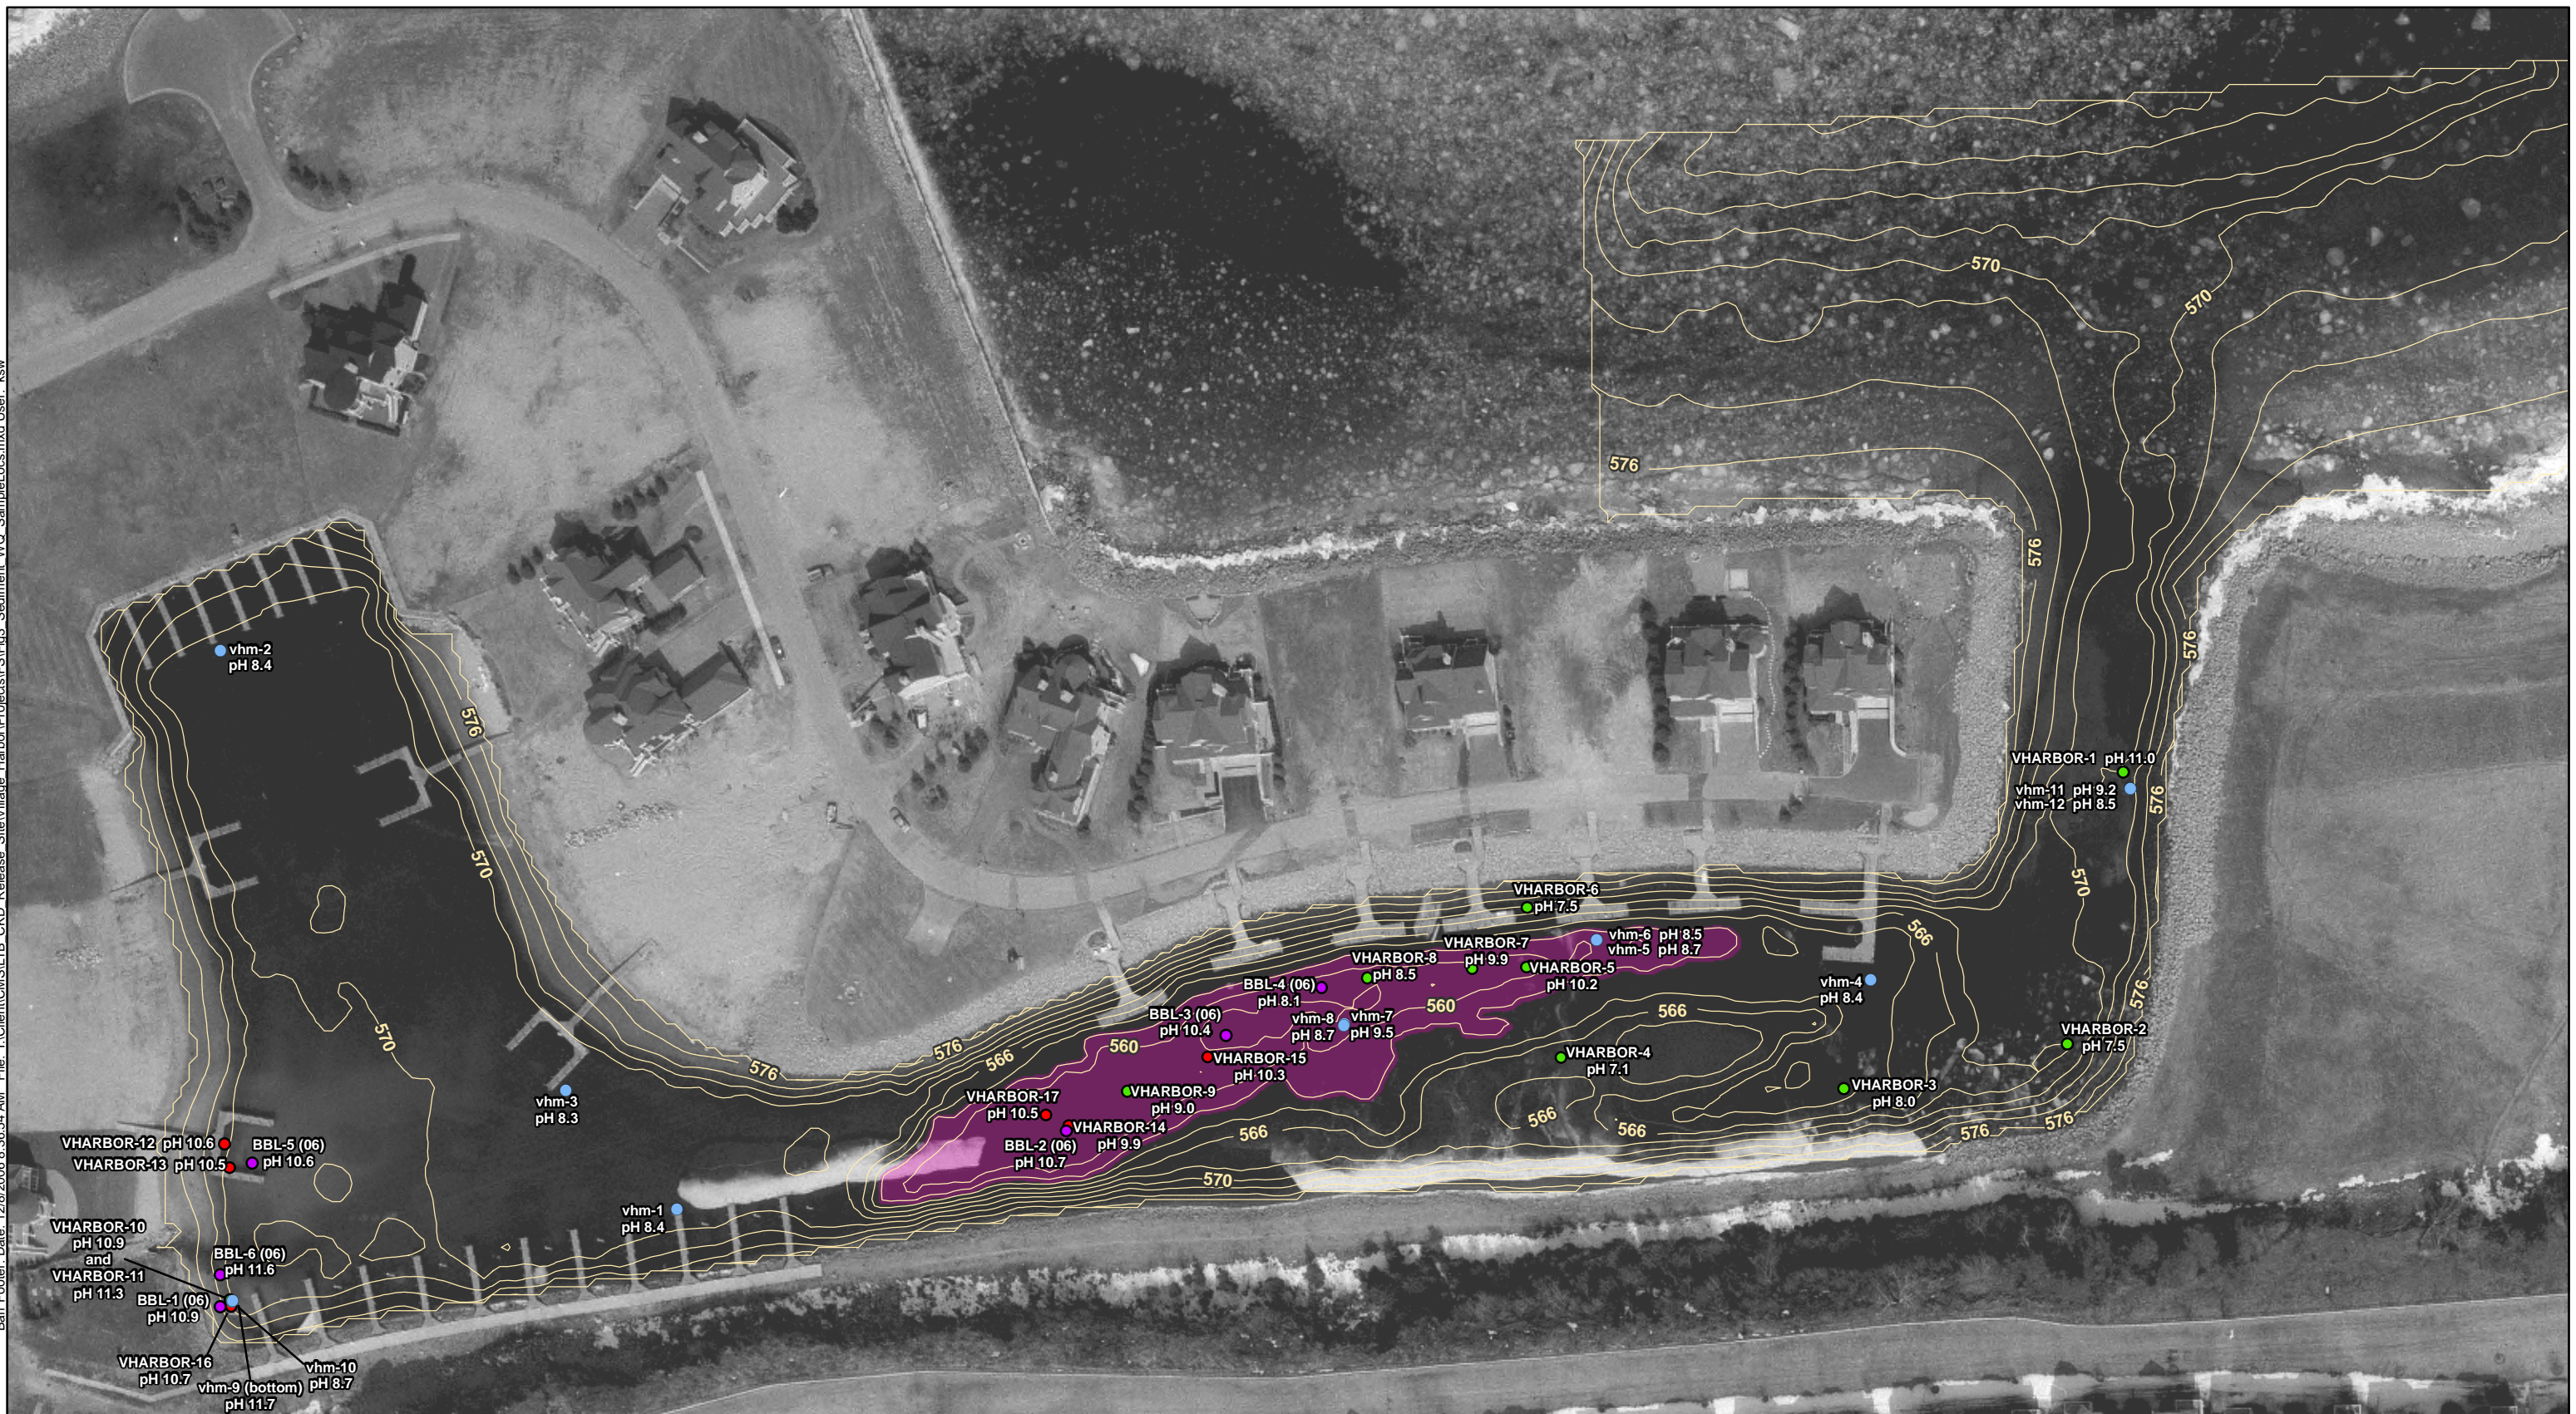
- June 2006 Sediment Sample Locations
- September 2006 Sediment Sample Locations
- June 2006 Water Sample Locations
- BBL 2006 Sediment Sample Locations

Extent of Sump Area (562 ft. contour)

Note: pH listed is the maximum pH observed
at sample location.
